Cleveland Landmarks Commission

Thursday, June 24, 2021

Enclosed within is a comprehensive Existing Building Assessment Report for the Turcios-Ruiz property located at 4805-4809 Lorain Avenue. The Report serves to summarize the condition of the existing building, as it relates to deficiencies per today's Building Code, as well as information describing existing structural, mechanical/plumbing, and electrical systems.

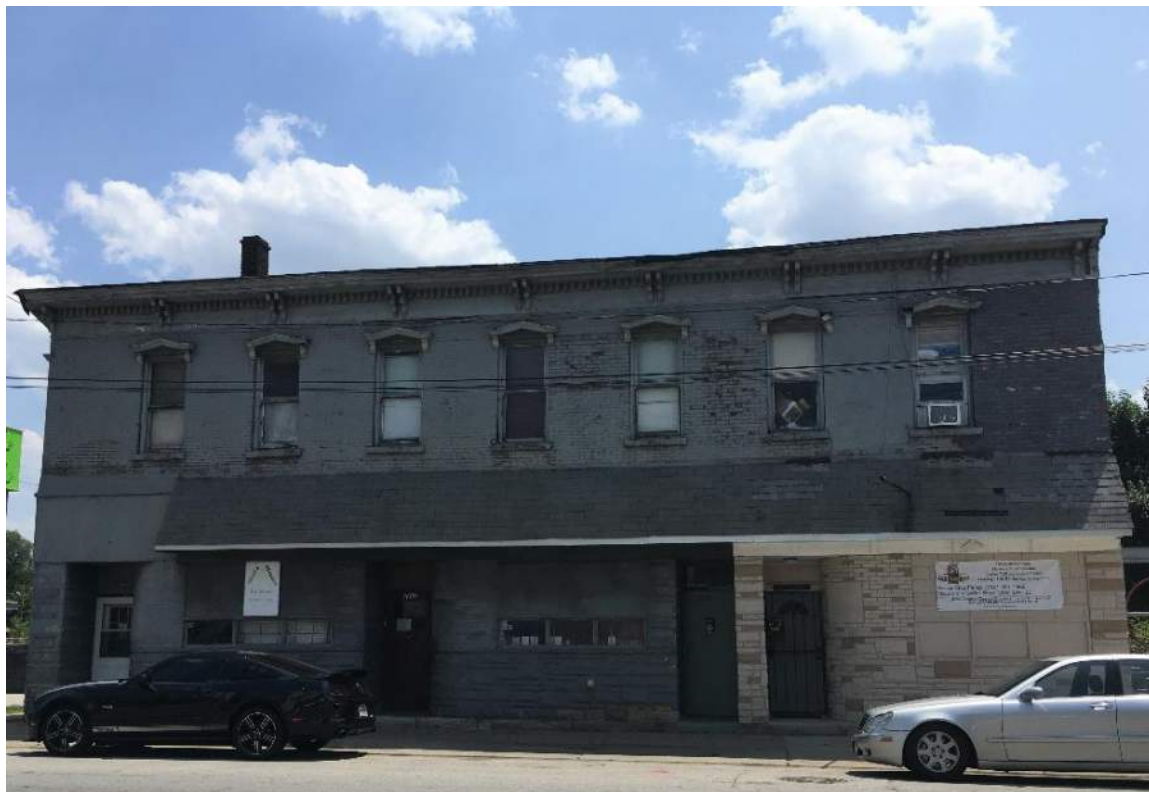
View of North Façade along Lorain Avenue

The general condition of the exterior walls is extremely poor.

The north elevation is clad in brick and stone. All masonry has been painted. The coating is peeling off of the majority of the masonry. The brick veneer at the second floor is bulging and pulling away from the wall and is at risk of collapse. The perimeter of the building should be cordoned off immediately to protect the public from the possibility of falling debris. Pinning and complete replacement of all brick in these areas would be required. The stone masonry foundation is in disrepair (see Part II of attached Evaluation Report by TBA).

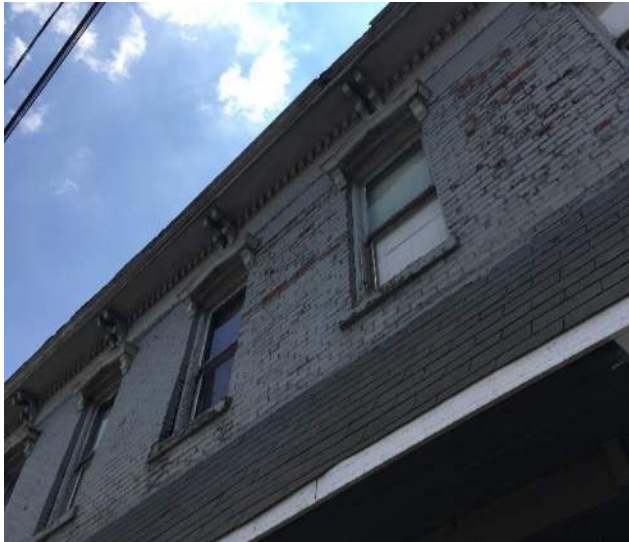
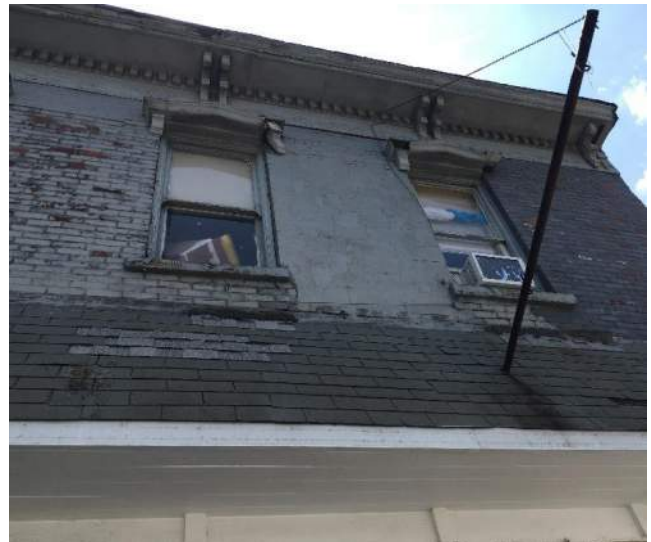
The masonry along the base of wall on the east elevation is crumbling and deteriorated. A large area of brick is bulging away from the wall. The stability of the masonry is unknown and presents a hazard for those walking on the adjacent sidewalk.

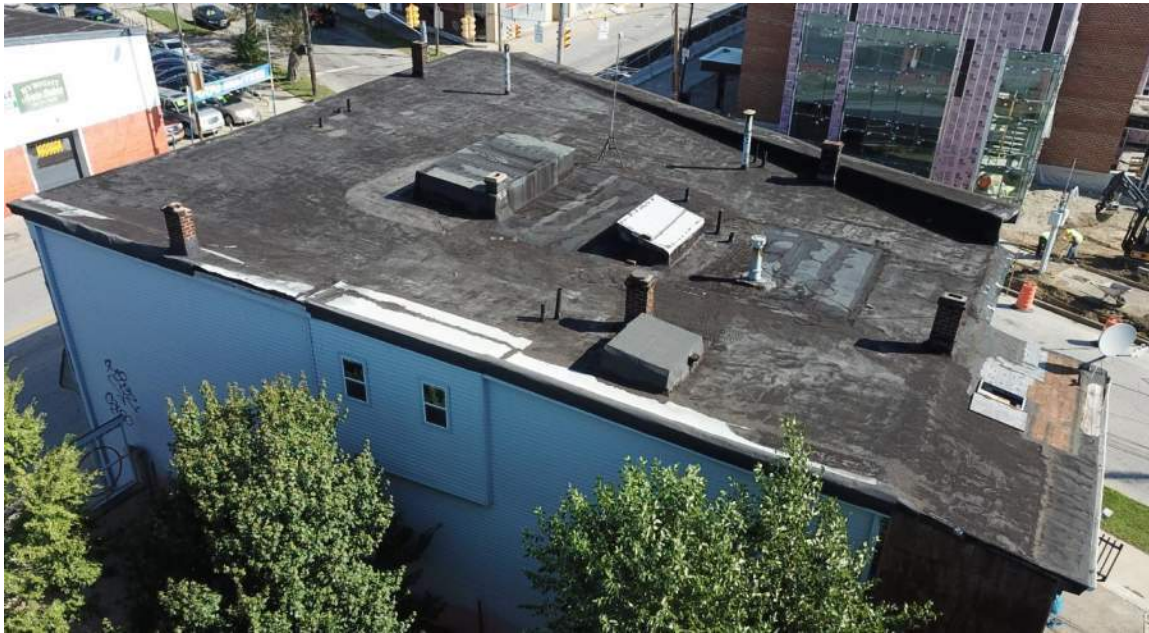
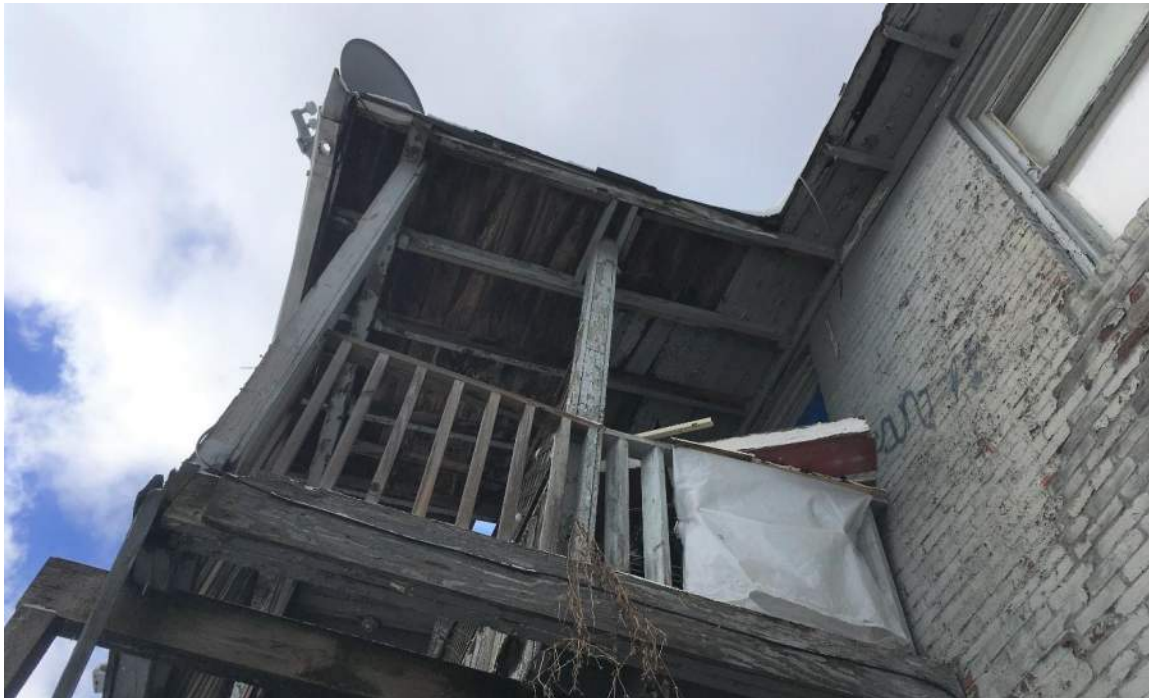
The age of the roof is unknown and consists of a mixture of roofing materials. Adequate edge terminations are not present. The roof structure slopes from north to south sending all stormwater to the south edges of the building. There is a gutter along the south edge of the porch roof. The downspout from this gutter has been removed. There is an open hole in the roof of the porch which allows water to fall onto the porch further damaging the wood structure. The portion of main roof east of the porch does not have a gutter so the water flows over the edge causing damage to the wood below. The exposed wood structure of the eave in this area is severely damaged. A new, complete roof system including edge trim, terminations, and drainage system is required. The condition of the roof structure is unknown.

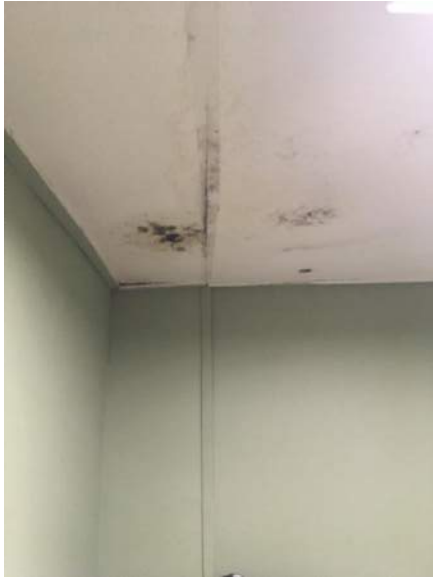
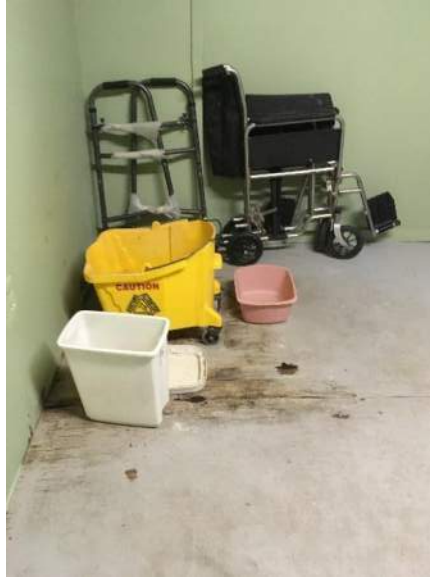
There is evidence of water damage in multiple areas on ceilings and floors.

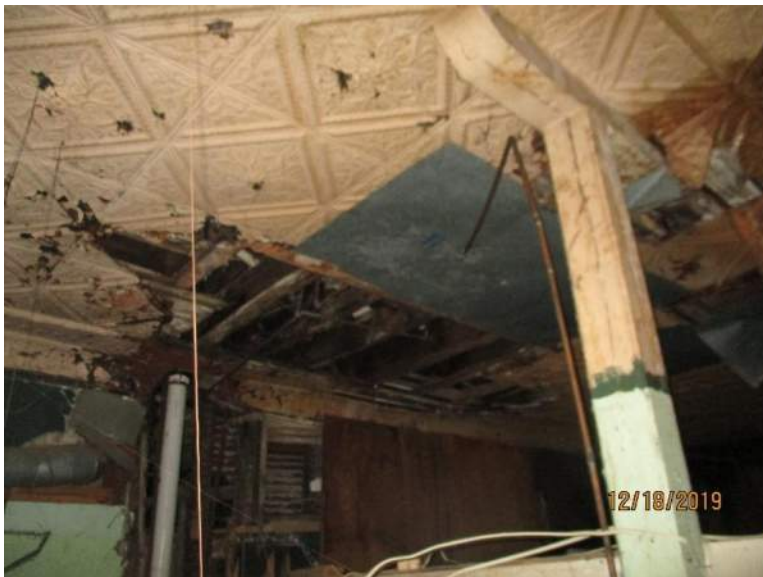
The majority of the first floor has suspended acoustical tile ceilings. Above the dropped ceiling, there is a tin ceiling attached to the floor joists. In at least one area, the tin ceiling has fallen away from the joists due to assumed water damage. Floor joists are exposed in the damaged area. By code there should be a fire separation between the first floor business use and residential floor above. A continuous fire separation does not exist.

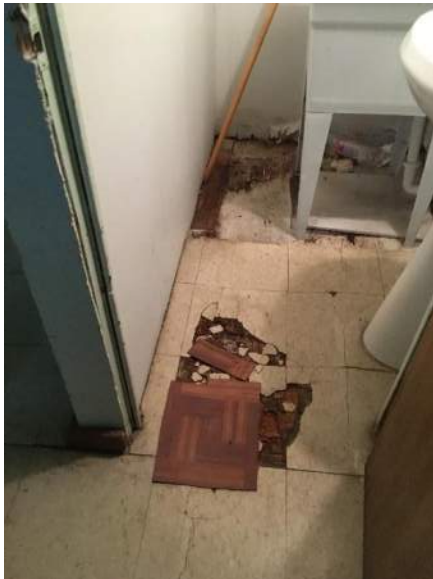
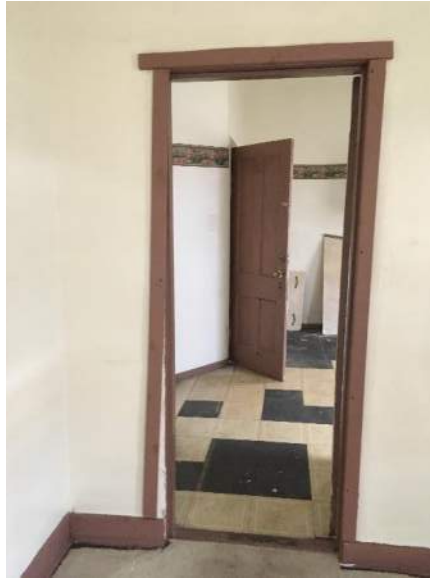
Generally, both the first and second floors are not level, potentially due to structural failure and decaying materials. The majority of spaces have loose and peeling floor finishes.

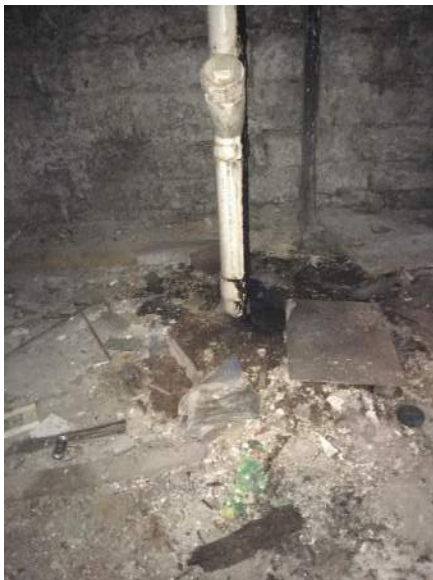
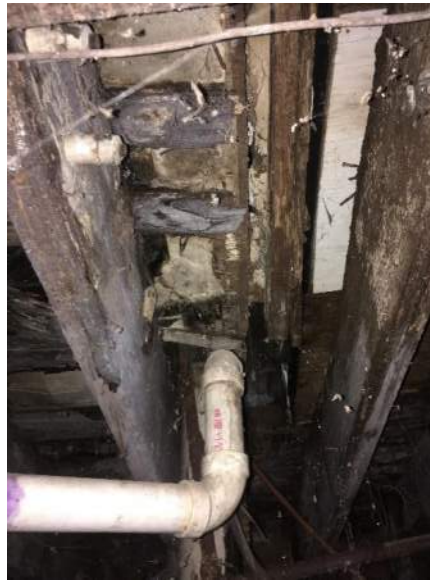
The southwest area of the basement is in the worst condition of the basement areas. The floor slab is cracked, damaged, and spalled. There is a sanitary stack that has been leaking raw sewage causing water damage. The structure above is also damaged (see Part II of attached Evaluation Report by TBA).

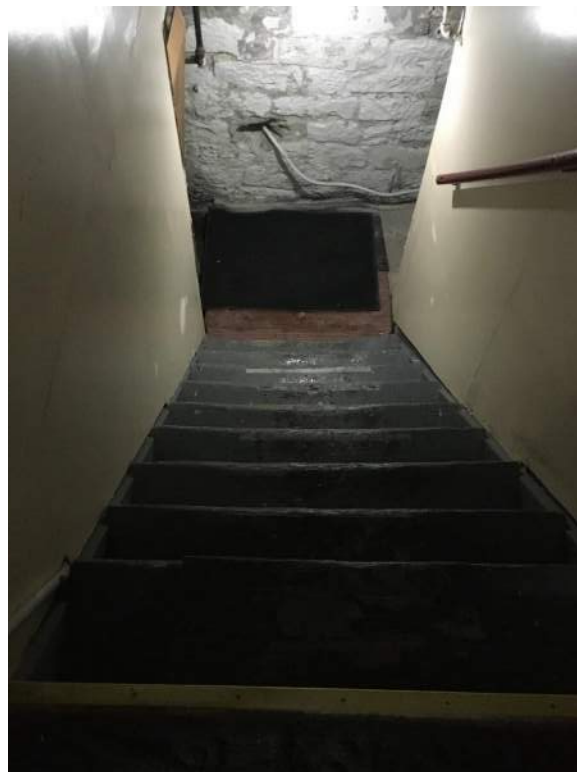
North stair to basement

The north basement area contains the incoming water service and gas service. The majority of area is used for storage. A portion of the basement appears to be used as a gathering space. There is an interior stairwell that leads from the church space on the ground level to the north area of the basement. The north stairwell is the only means of egress from the basement. One exit is acceptable up to an occupant load of 49, however the condition of the stair is not code compliant. Solid risers are required and the treads are worn and nonuniform. Handrails with proper extensions at the top and bottom are required on both sides of the stair.

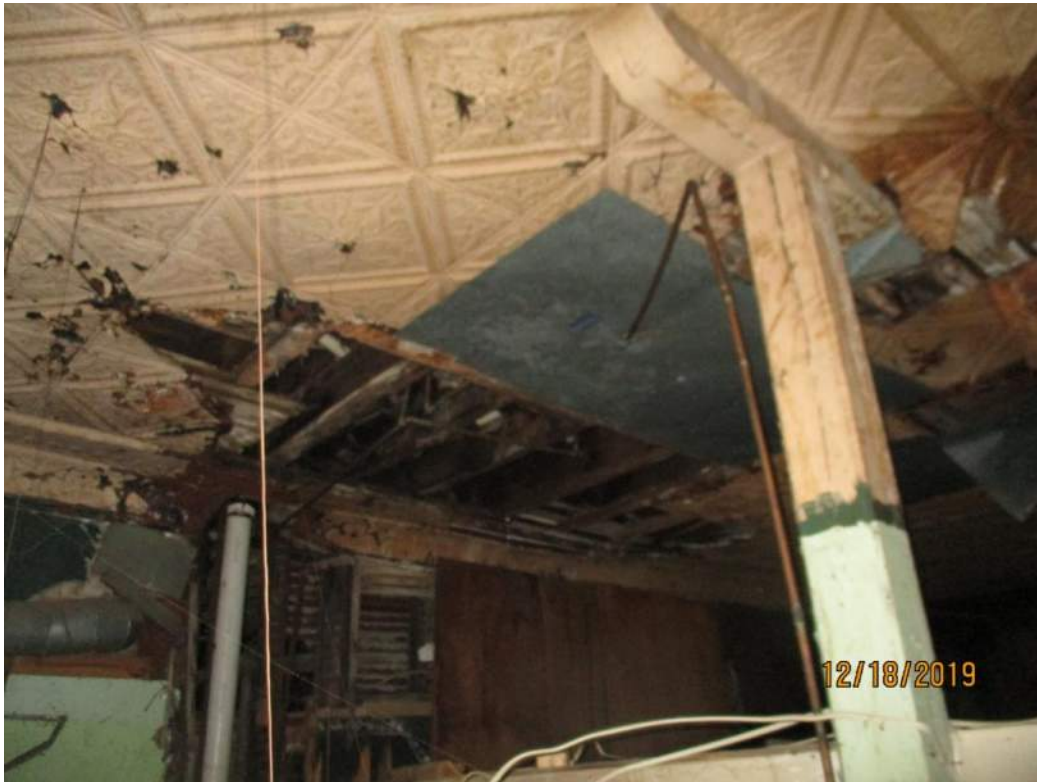
5. There was also a 4x10 girder beam post line along the perimeter of the building. I.E. the first floor wood framing is independent of the exterior basement stone walls. ***The same issues described above also apply along this perimeter and TBA recommends structural repairs be made immediately.***

Existing 4x10 girder beam not supported by wall and no wood post in place

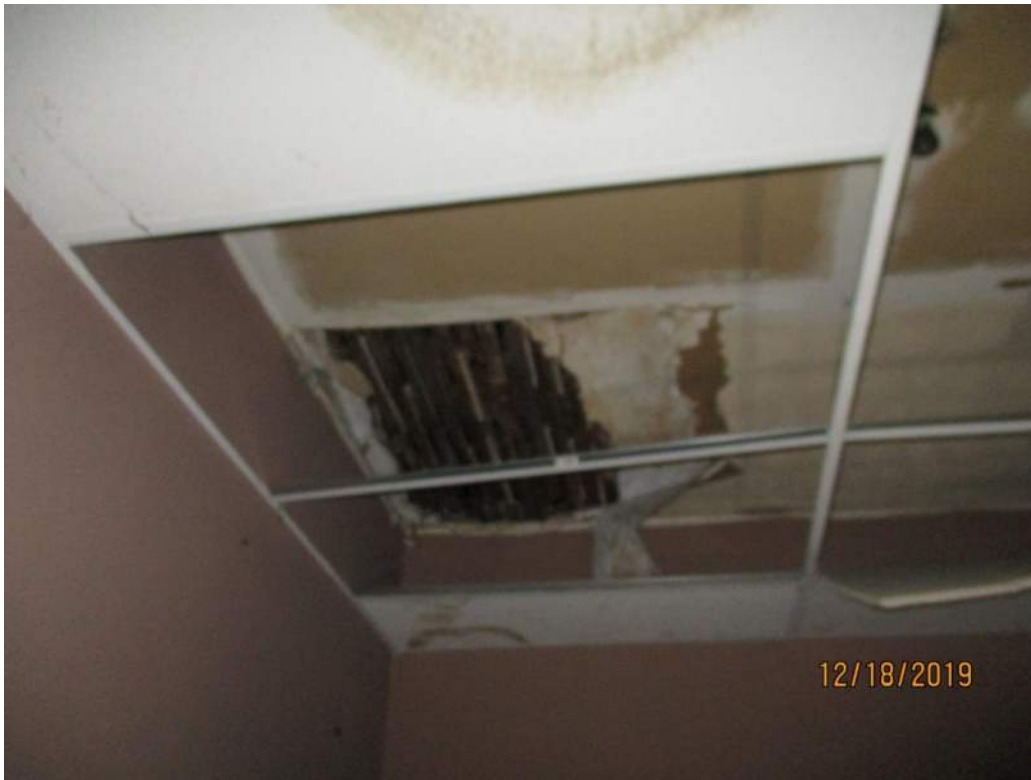
6. A small area of the first floor framing appeared to have suffered some water damage from leaks above. This water damage coupled with the first floor framing issues described above in item 4 have caused the floor to sag down approximately 2"-3". This much deflection in the floor joist creates additional stress in the 2x12 sawn lumber member. ***TBA recommends structural repairs in this area be made immediately.***

Water damage to second and first floor framing due to second floor bathroom

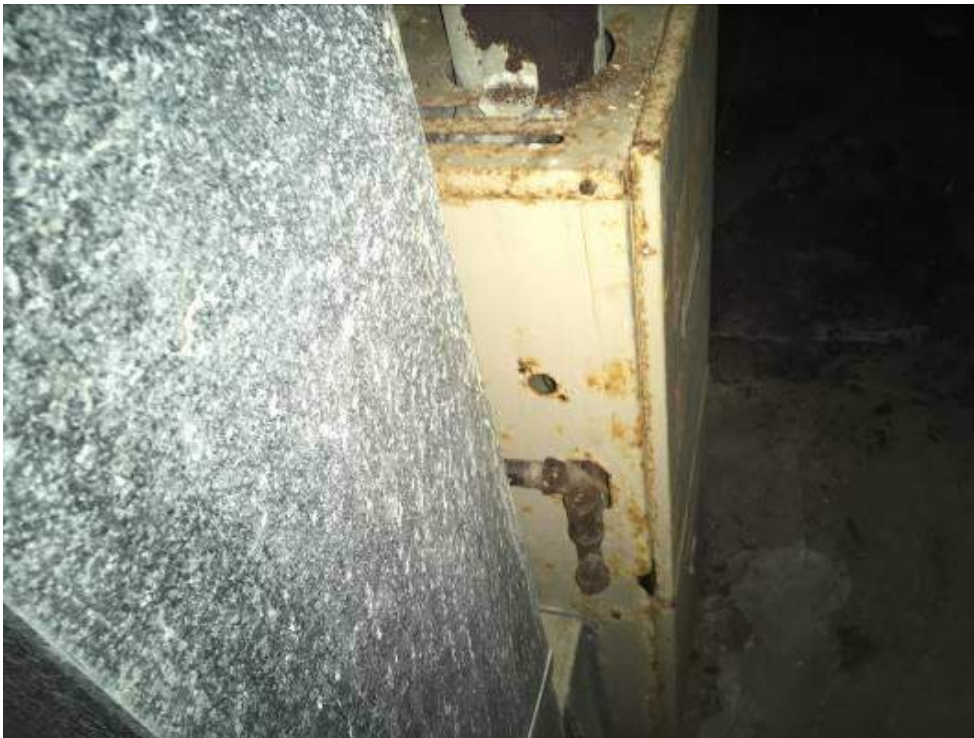
Abandoned second floor furnaces

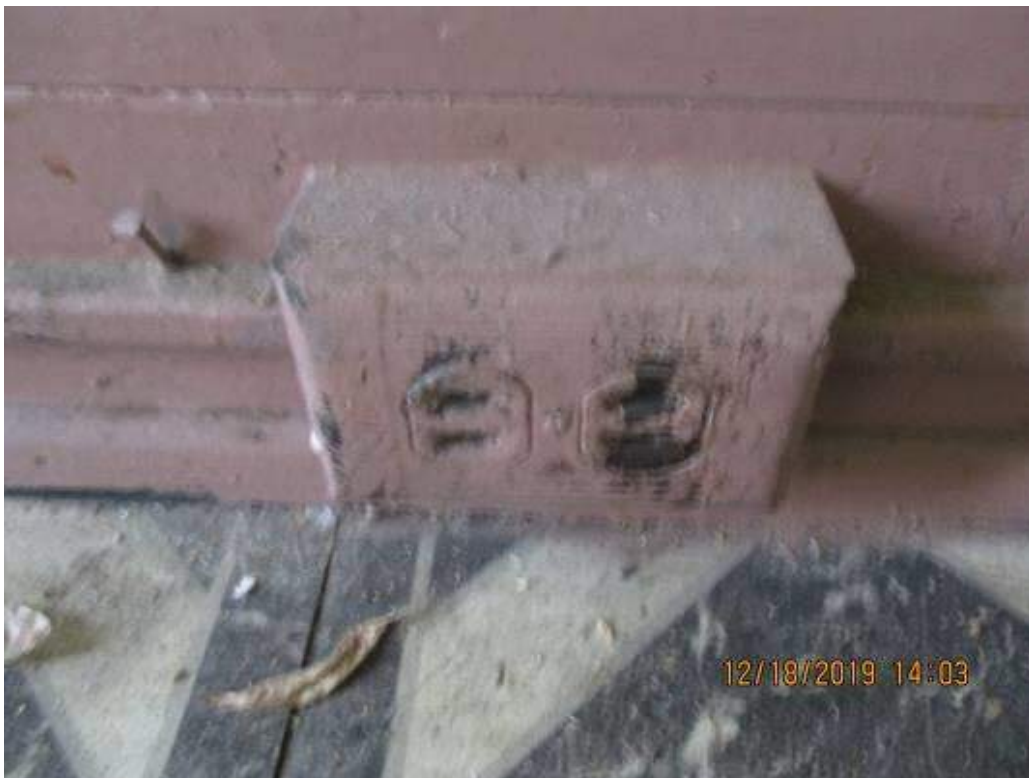
Deteriorated and ungrounded or questionably grounded receptacles

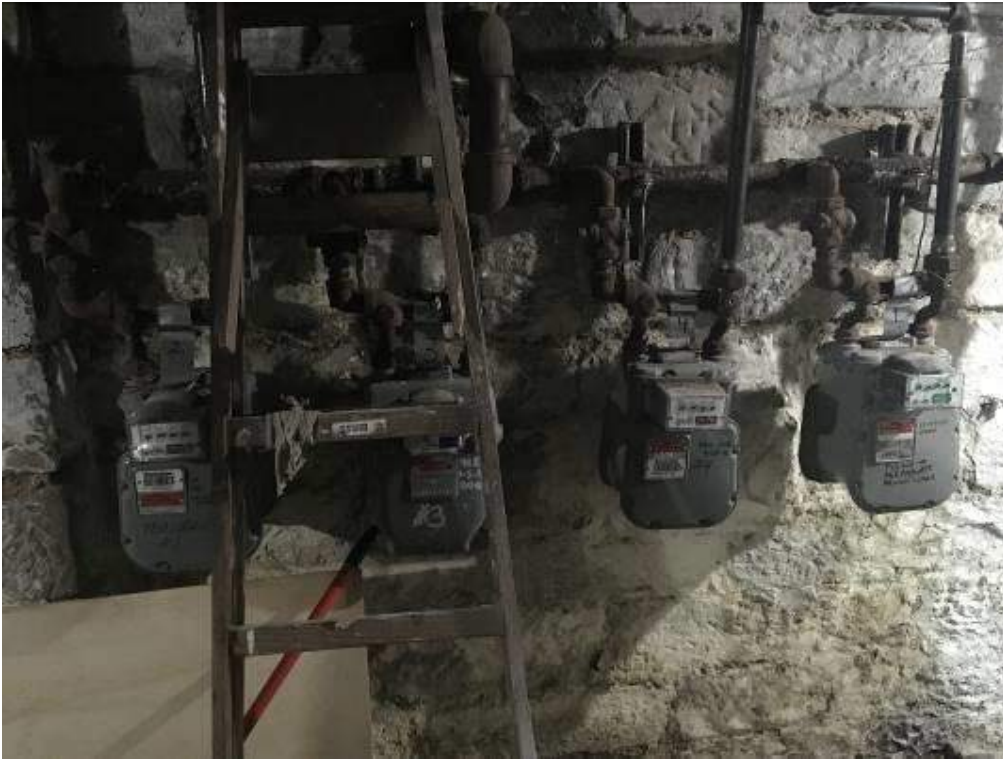
- a. Gas is then distributed to a manifold with five gas meters.
 - b. ***The gas manifold itself is extremely heavily corroded and rusted, which has the possibility of bringing gas leaks.***

Rusted gas manifold

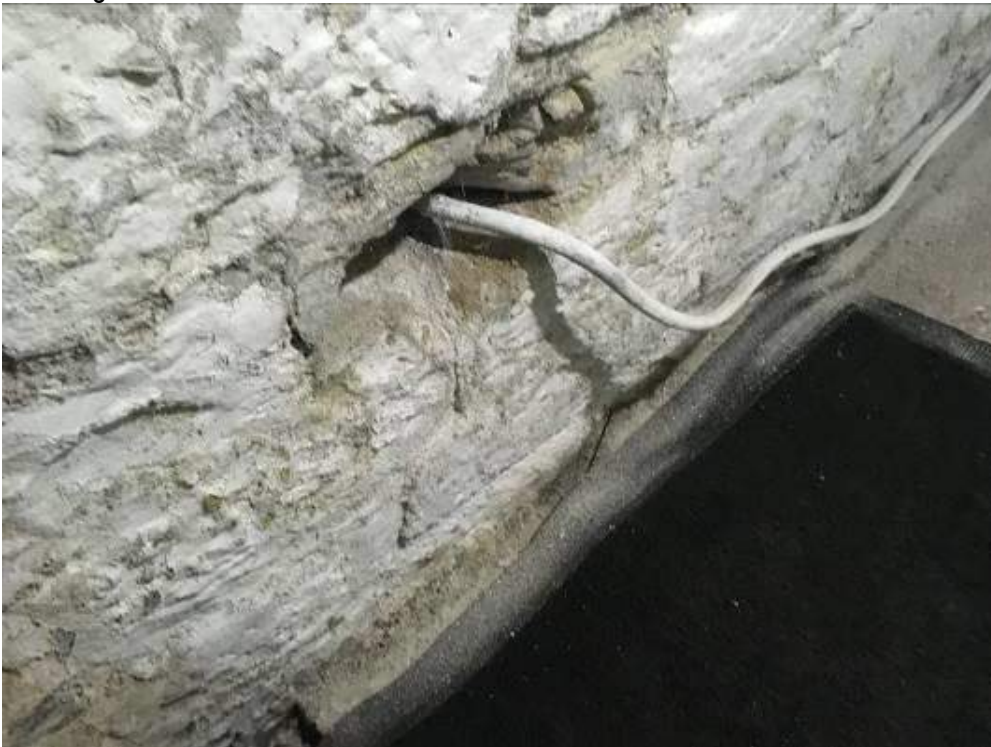
1", undersized water entry
