GENERAL CONSTRUCTION NOTES FOR FIRST FLOOR

FIRST FLOOR ROOM FINISH SCHEDULE

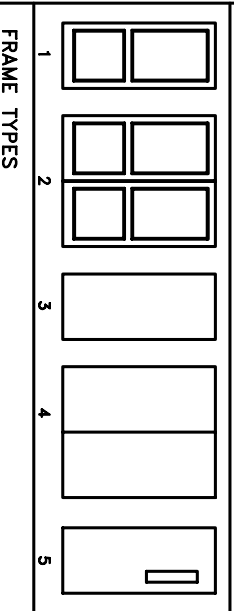
DOOR TYPES

NOTES:
 1. FIELD VERIFY EXIST. ROUGH OPENING BEFORE FABRICATION OF DOOR.
 2. SMALL REMAINING OF 3/4" THICK.
 3. ALL EXIST. DOORS TO REMAIN SHALL BE REFRESHED, REFINISH EXIST. HARDWARE. INSTALL NEW HARDWARE AT DOORS WHERE EXIST. IS DAMAGED.
