Cleveland Landmarks Commission

Thursday, June 24, 2021

Enclosed within is a comprehensive Existing Building Assessment Report for the Turcios-Ruiz property located at 4805-4809 Lorain Avenue. The Report serves to summarize the condition of the existing building, as it relates to deficiencies per today's Building Code, as well as information describing existing structural, mechanical/plumbing, and electrical systems.

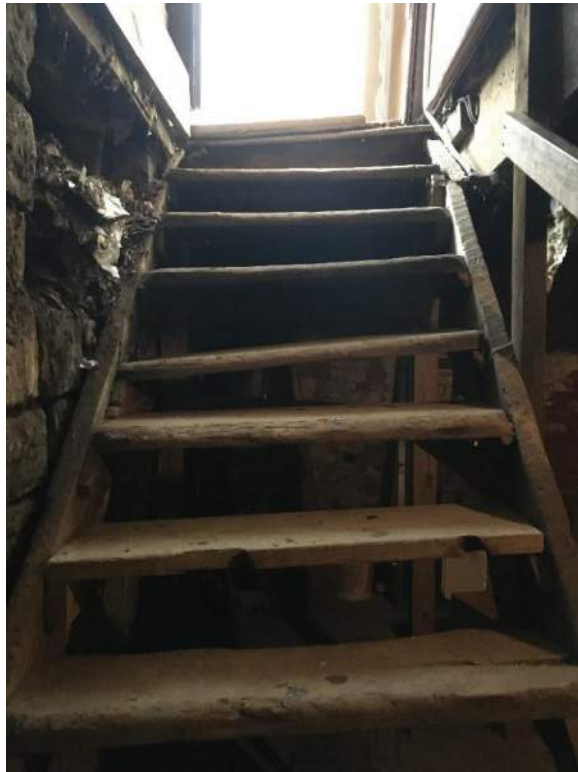
The basement is divided into two areas. The south portion of the building is unoccupied and contains electrical panels and furnace units (see Parts III and IV of attached Evaluation Report by TBA). Access to the south area is through an exterior door that leads to a wood staircase. The steps are extremely inconsistent in dimension and stability, do not have adequate handrails, and have open risers which are prohibited by code. A safe, code compliant means of egress from this area is not provided and is required by code.

South stair to basement

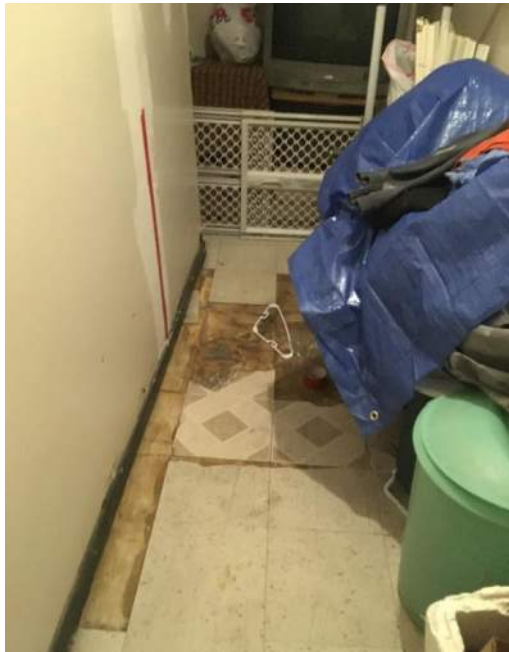
The upper residential level is accessed via an interior stair on the north end of the building. This stair is very steep and is not code compliant. The second means of egress from the upper floor is through a door on the south wall leading to the exterior porch and staircase. This door is blocked and the porch and stair structures on the south façade are structurally unsound (see Part II of attached Evaluation Report by TBA). The hallway leading to the south door is used for storage and is blocked by a baby gate. A clear, second means of egress is required by code.

Second floor hallway

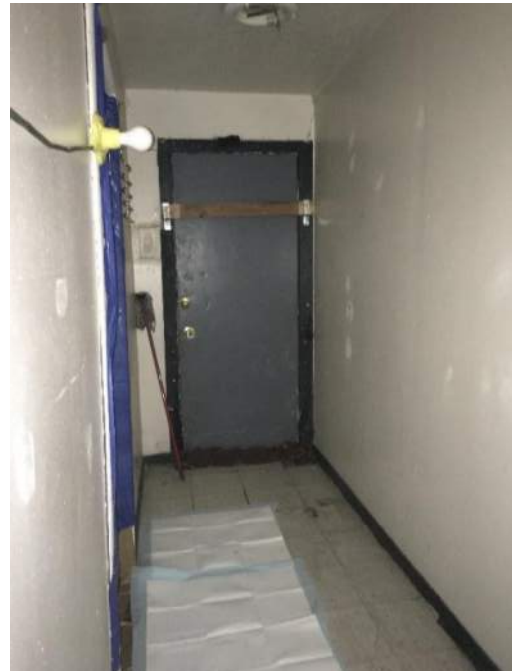
Second floor hallway

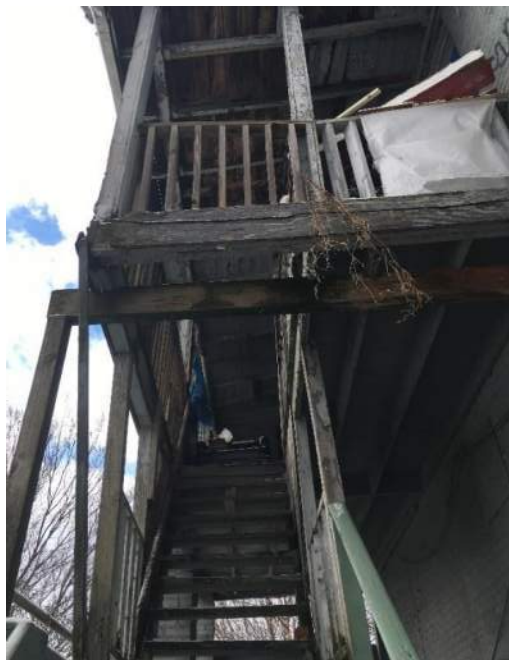
Porch and exterior stair

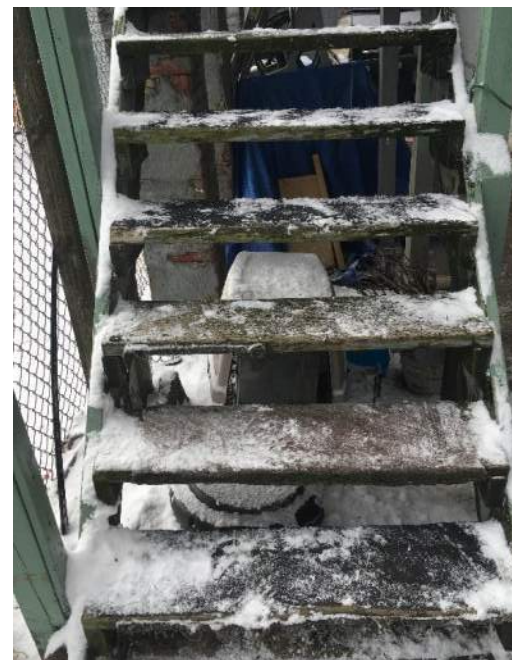
Exterior steps

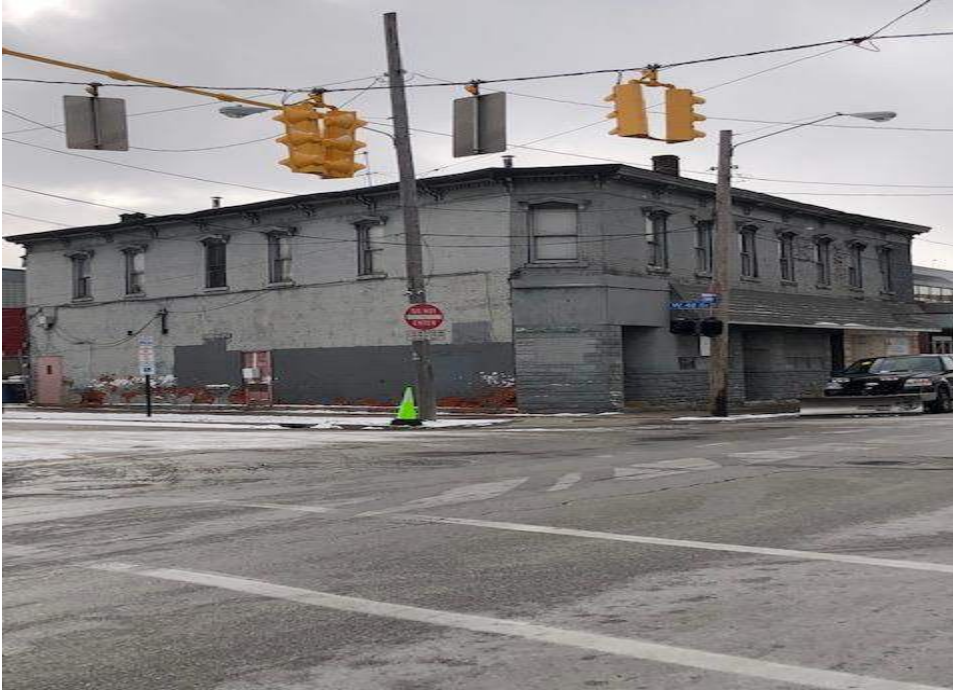
5. The East elevation has severely eroded sections of brick veneer at the grade level that require replacement. Areas of displaced and bulging brick veneer also exist at the second-floor line.

Exterior North and East Elevations

In summary the masonry façade is in very poor condition. The existence of displaced and bulging locations of the façade are a serious concern, especially with the fact that the West elevation collapsed in previous years. The façade requires to be anchored to a solid back up system. The present condition and previous failure of the West elevation and locations of the North elevation questions the existence or lack of a tie system for the masonry façade. It is our opinion that the masonry façade is not salvageable and requires replacement with new masonry units and a properly designed tie system to the back up structure.

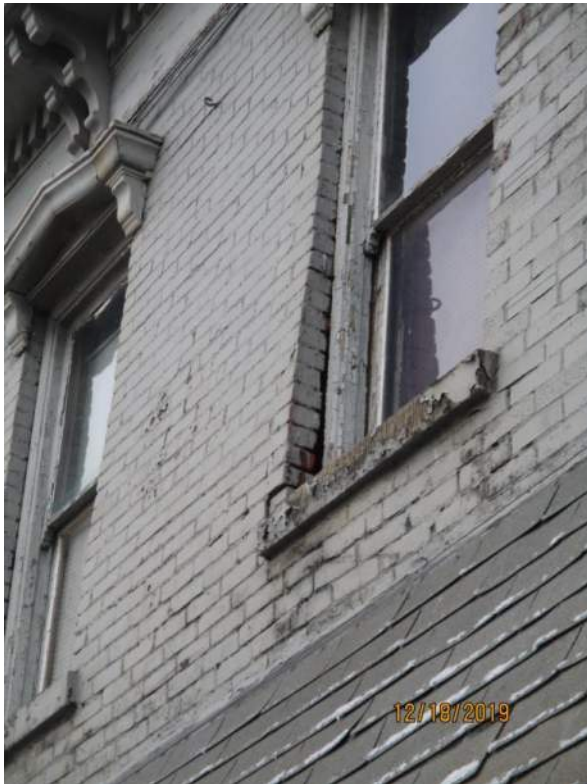
3. The brick and stone façade is covered with a paint coating that is peeling and flaking on all elevations.
4. The North elevation upper façade has areas of displaced and bulging brick. The brick veneer has failed in areas and was replaced with a concrete block veneer.

The north elevation is clad in brick and stone. All masonry has been painted. The coating is peeling off of the majority of the masonry. The brick veneer at the second floor is bulging and pulling away from the wall and is at risk of collapse. The perimeter of the building should be cordoned off immediately to protect the public from the possibility of falling debris. Pinning and complete replacement of all brick in these areas would be required. The stone masonry foundation is in disrepair (see Part II of attached Evaluation Report by TBA).

North exterior elevation brick veneer pushing out

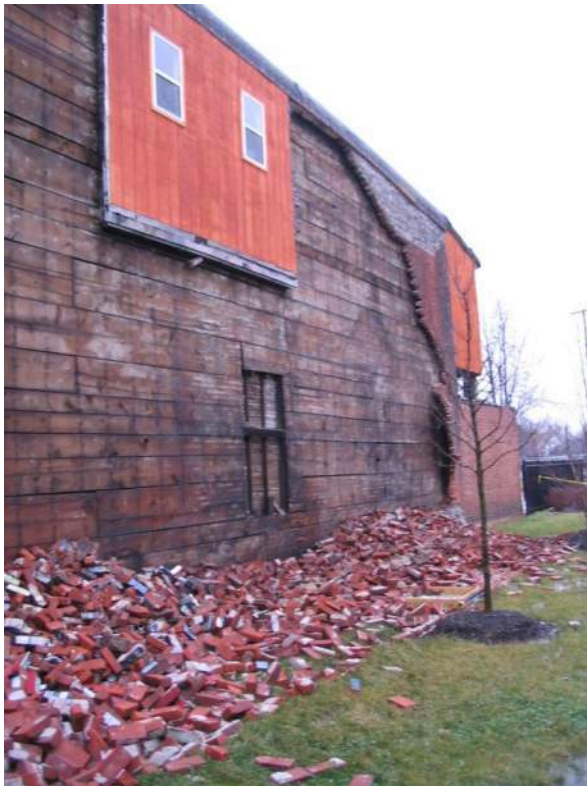
2. We were informed that the West elevation originally was clad in a brick veneer. This veneer collapsed in previous years and was replaced with siding.

West elevation prior brick veneer collapse

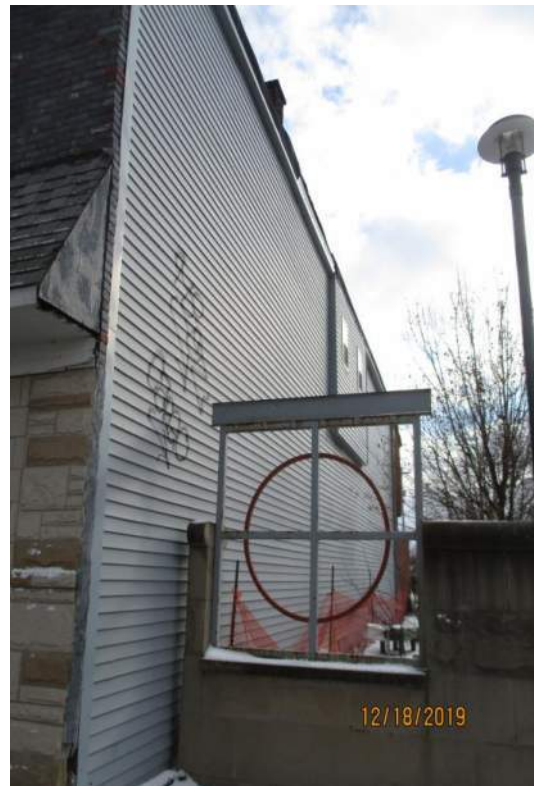
Current West elevation

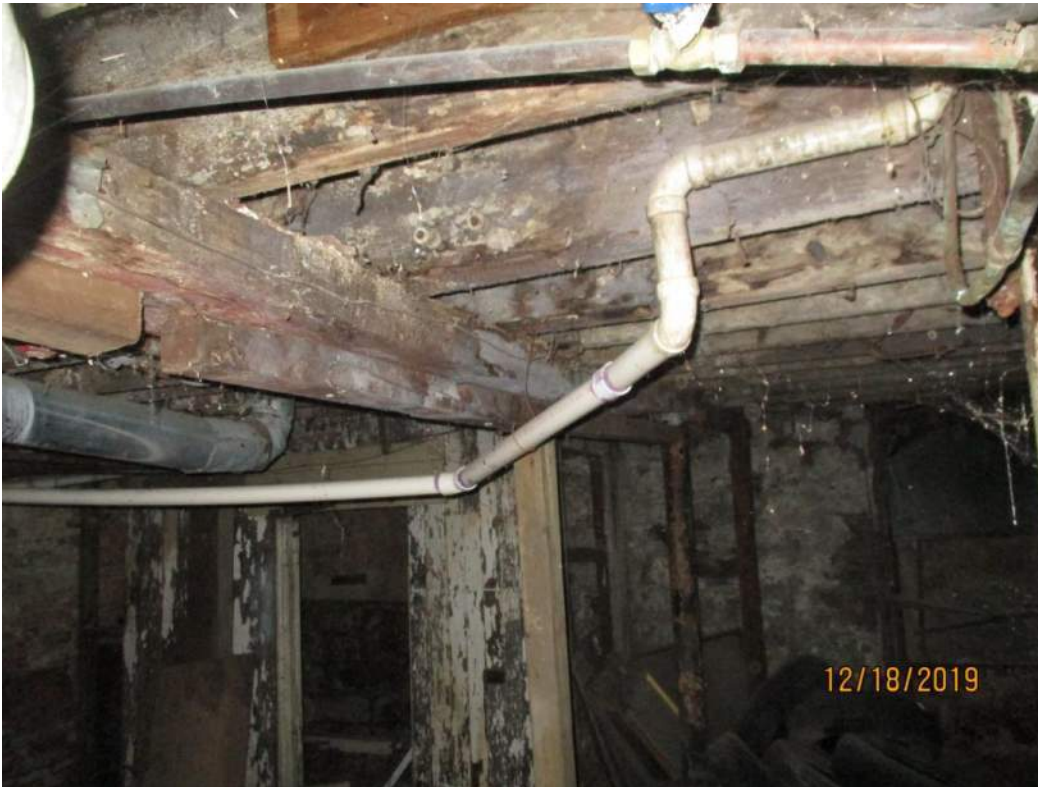
Existing 4x10 girder beam line with post removed and floor sagging approx. -2"

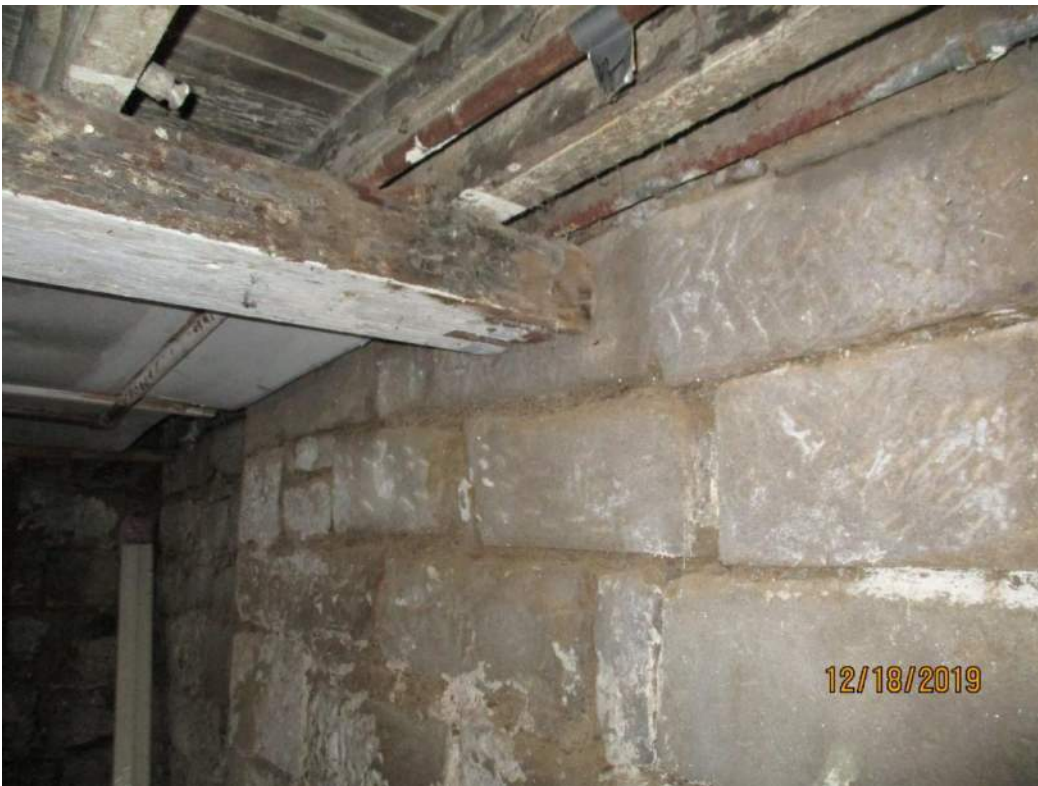
Existing 4x10 girder beam not supported by wall and no wood post in place

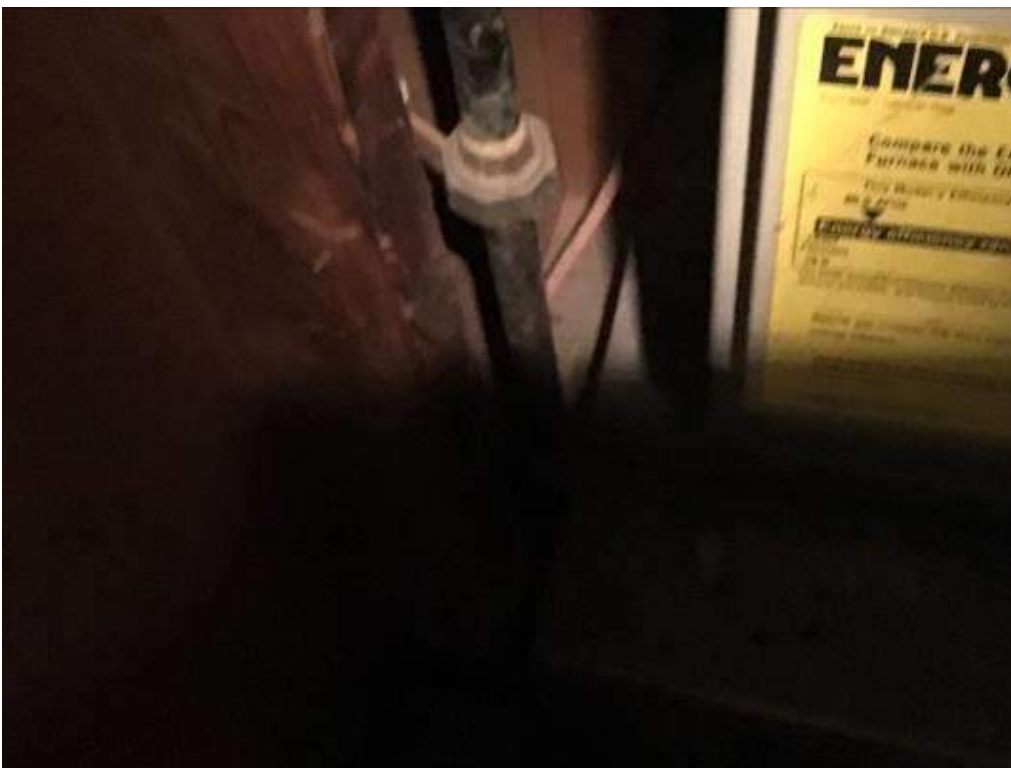
Pipe union in resident suite furnace plenum
